CORRECTIVE ACTION STABILIZATION QUESTIONNAIRE

Facility Name: Southern Illinois University Science BuildingEPA Identification No.: ILD 006 331 342Location (City, State): Edwardsville, IllinoisFacility Priority Rank: Low

PRC Environmental Management, Inc. (PRC), performed a preliminary assessment and visual site inspection (PA/VSI) to identify and assess the existence and likelihood of releases from solid waste management units (SWMU) and other areas of concern (AOC) at the Southern Illinois University, Science Building (SIUSB) facility in Edwardsville, Illinois. This report summarizes the results of the PA/VSI and evaluates the potential for releases of hazardous wastes or hazardous constituents from the SWMUs identified. In addition, a completed U.S. Environmental Protection Agency (EPA) Preliminary Assessment Form (EPA Form 2070-12) is included in Attachment A to assist in prioritization of RCRA facilities for corrective action.

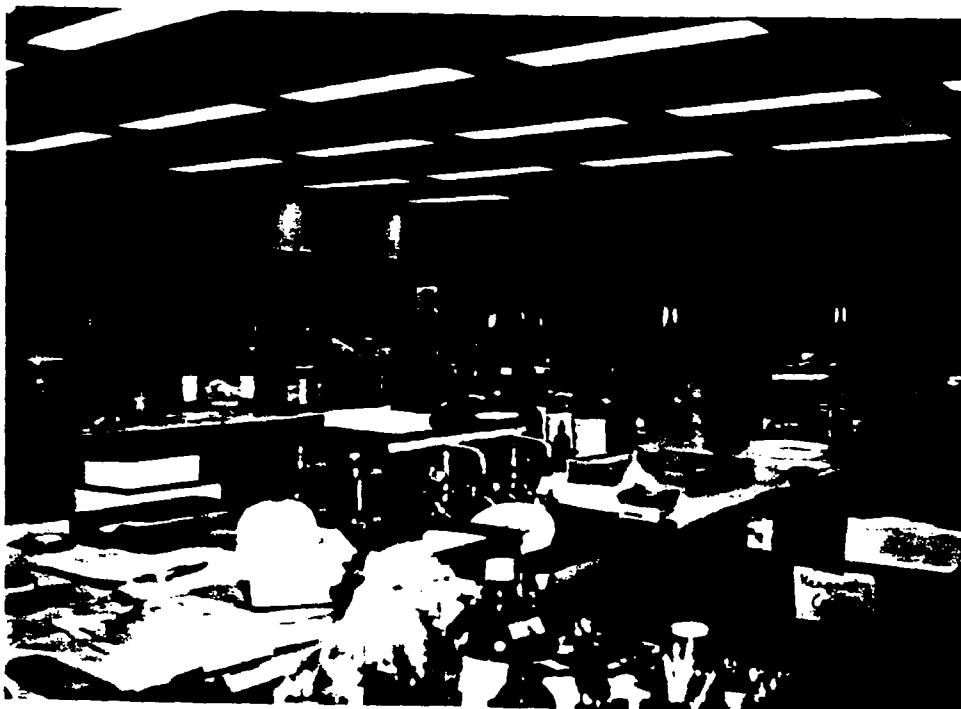
Location: SWMU 2
 Date: 01/08/92

Observations: No visible contamination was observed in the vicinity of this SWMU during the VSI. There are no floor drains in the treatment area (see Photo No. 2).

Photograph No. 2
 Orientation: Southwest
 Description: Hazardous waste treatment area in room SL-1209. Three of five fumehoods used for treatment can be seen at the upper right corner of the photo.

Recommendations: The facility has submitted a RCRA closure plan for this unit to IEPA and is currently awaiting response from IEPA. No further action is recommended at this time.

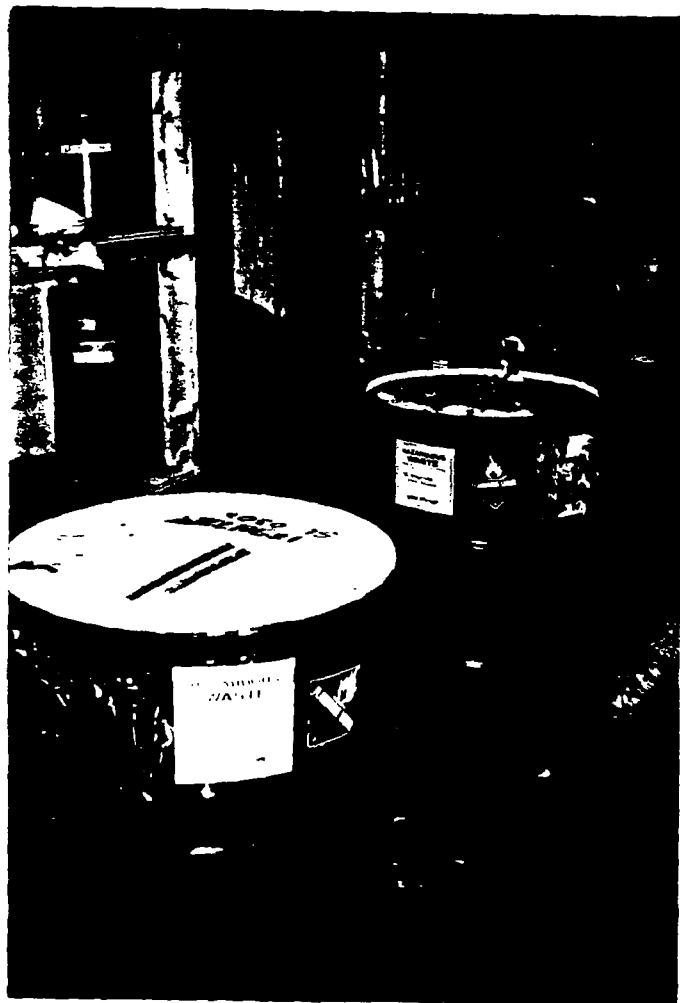
Location: SWMU 3
Date: 01/08/92

Unit Description: This unit is located in room SL-0308 on the ground floor of the Science Building. It is used to store hazardous wastes for greater than 90 days (process code S01). It has an area of 289 square feet and a capacity for storing 200 gallons of waste. The ceiling material consists of 2.5-foot wide concrete slabs that run the entire length of the room. The walls are cinder block construction on all sides, except for the south wall. The south wall is constructed of brick and mortar material. The floor is concrete with no floor drains. The floor is several inches lower than all the exits from the room. A concrete curb provides containment. At present, in addition to the storage of hazardous waste, this unit also stores some of the chemicals required by the university laboratories. The room also contains substances that are listed in the Illinois Material Exchange Program. The chemicals are stored on wood shelves (SIUSB, 1991) (see Photo No. 3).

A 5-gallon pail of waste entitled "nonhalogenated solvent only" was found leaking on the floor of this unit on February 14, 1990. Apparently, approximately 2 gallons were released. The spill was contained by a clayey absorbent material (U.S. EPA, 1990a).

No visible contamination was observed in the vicinity of this SWMU during the VSI. No cracks or floor drains were observed on the concrete floor (see Photo No. 3).

Photograph No. 3
Orientation: Northwest
Description: Hazardous waste container storage area in room SL-0308

The facility has submitted a RCRA closure plan for this unit to IEPA and is currently awaiting response from IEPA. This unit is undergoing RCRA closure. No further action is recommended at this time.
